Bureau of Mines Report of Investigations/1983

Experimental Drift Linings in a Block-Caving Operation— A Field Demonstration

Report of Investigations 8811

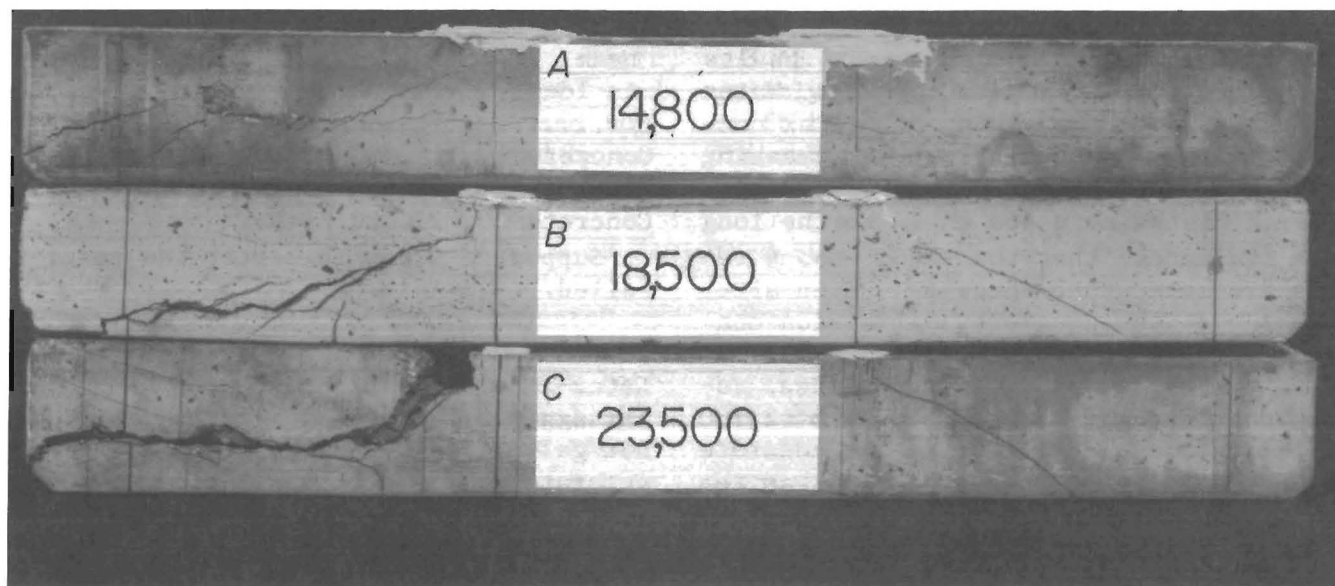
Table 1 and figure 4 show test results of the prototype concrete lagging. Water is critical in the mixing of latex concrete, hence a variation in breaking strength. The laboratory failure (fig. 4) with cracks at a low angle to the long axis indicates that the three No. 6 rebars are more than adequate. Even after cracking of the concrete, deflection continues; lagging 3 initially failed at 18,500 lb (8,392 kg), but the steel rebars continued to support 4,850 lb (2,200 kg) after concrete failure. The concrete is more expensive than wood but has the advantage of fire resistance, and it is not susceptible to dry rot.

FIGURE 4. - Concrete lagging flexure test showing failure weight, in pounds. A, Concrete 1; B, concrete 2; C, concrete 3.

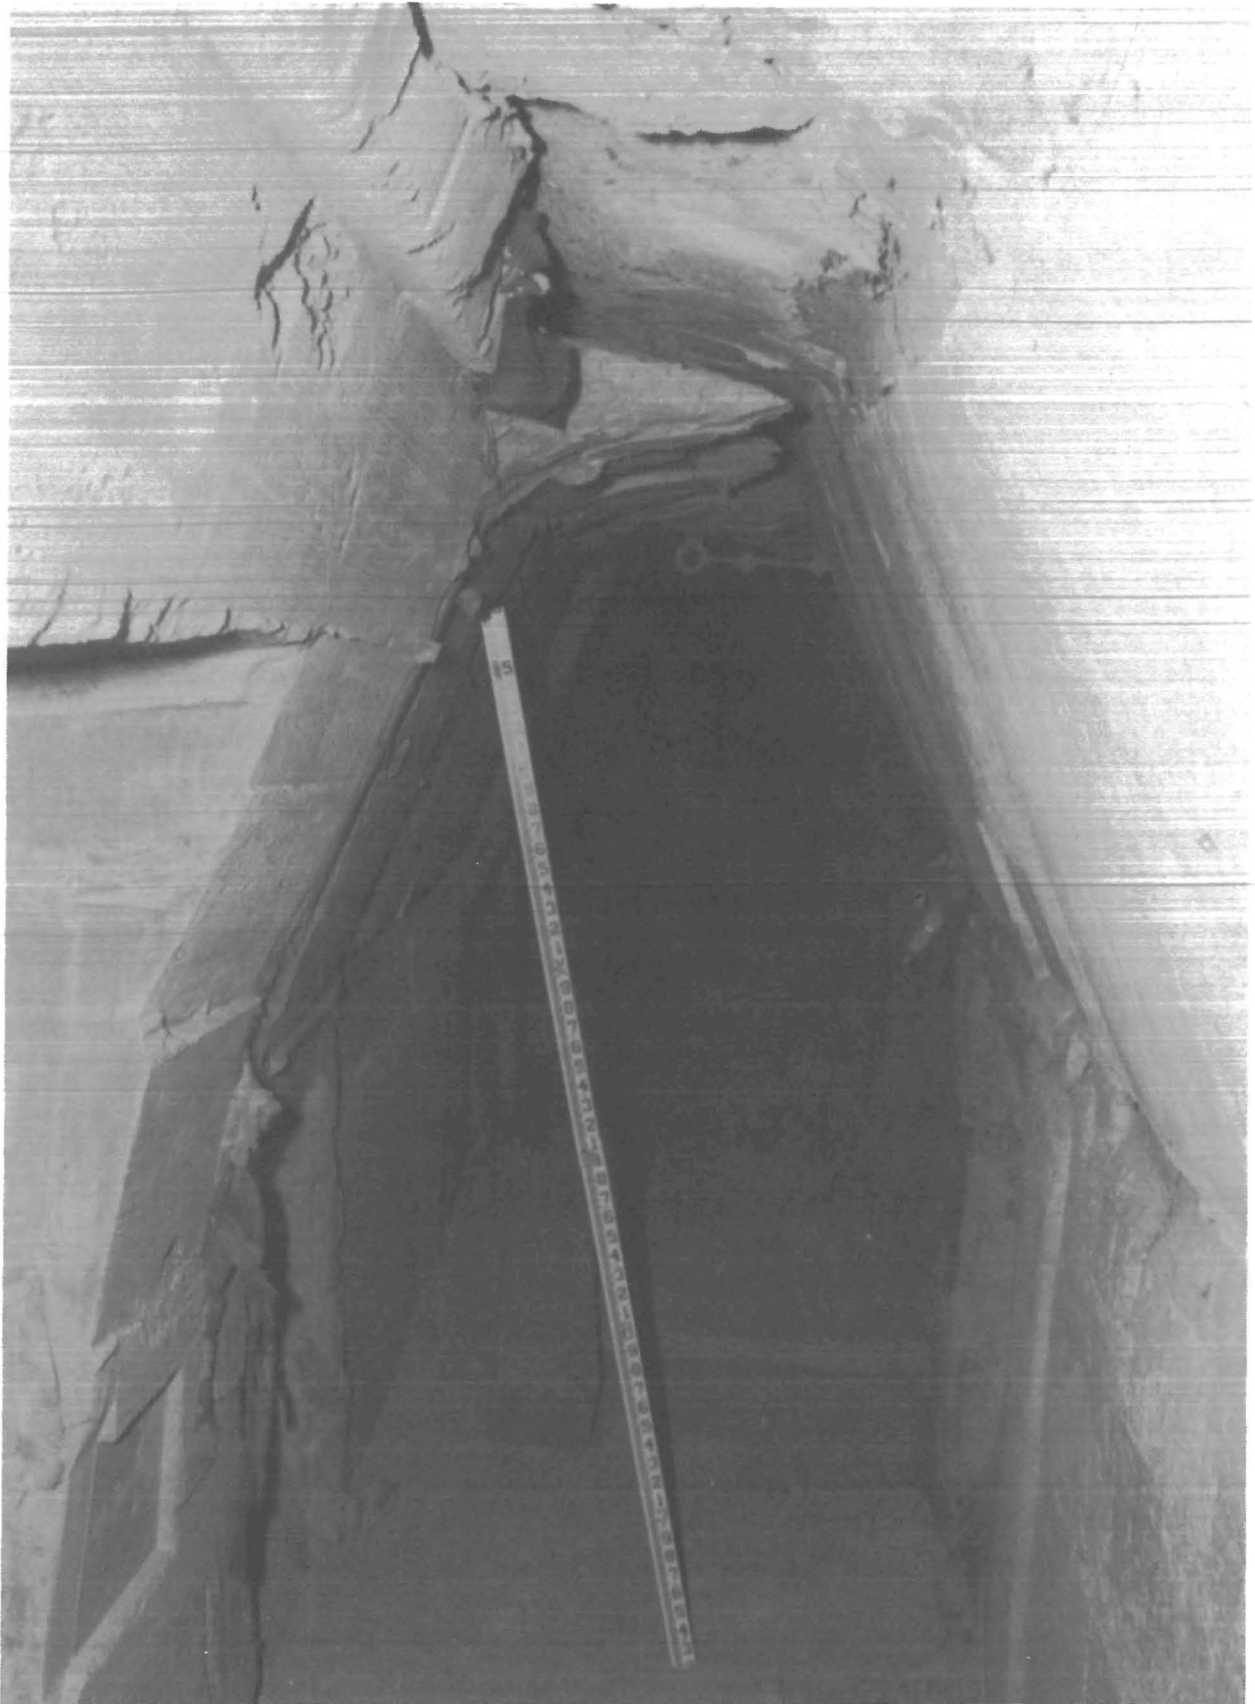
Actual closure was measured at just under 3 in (7.62 cm). No failure of the lining occurred during undercutting nor subsequent drawing of the block. Figure 14 shows the lining in good condition after the block was mined; figure 15 shows adjacent concrete damage.

FIGURE 15. - Monolithic concrete failure adjacent to 2315 grizzly level test drift.

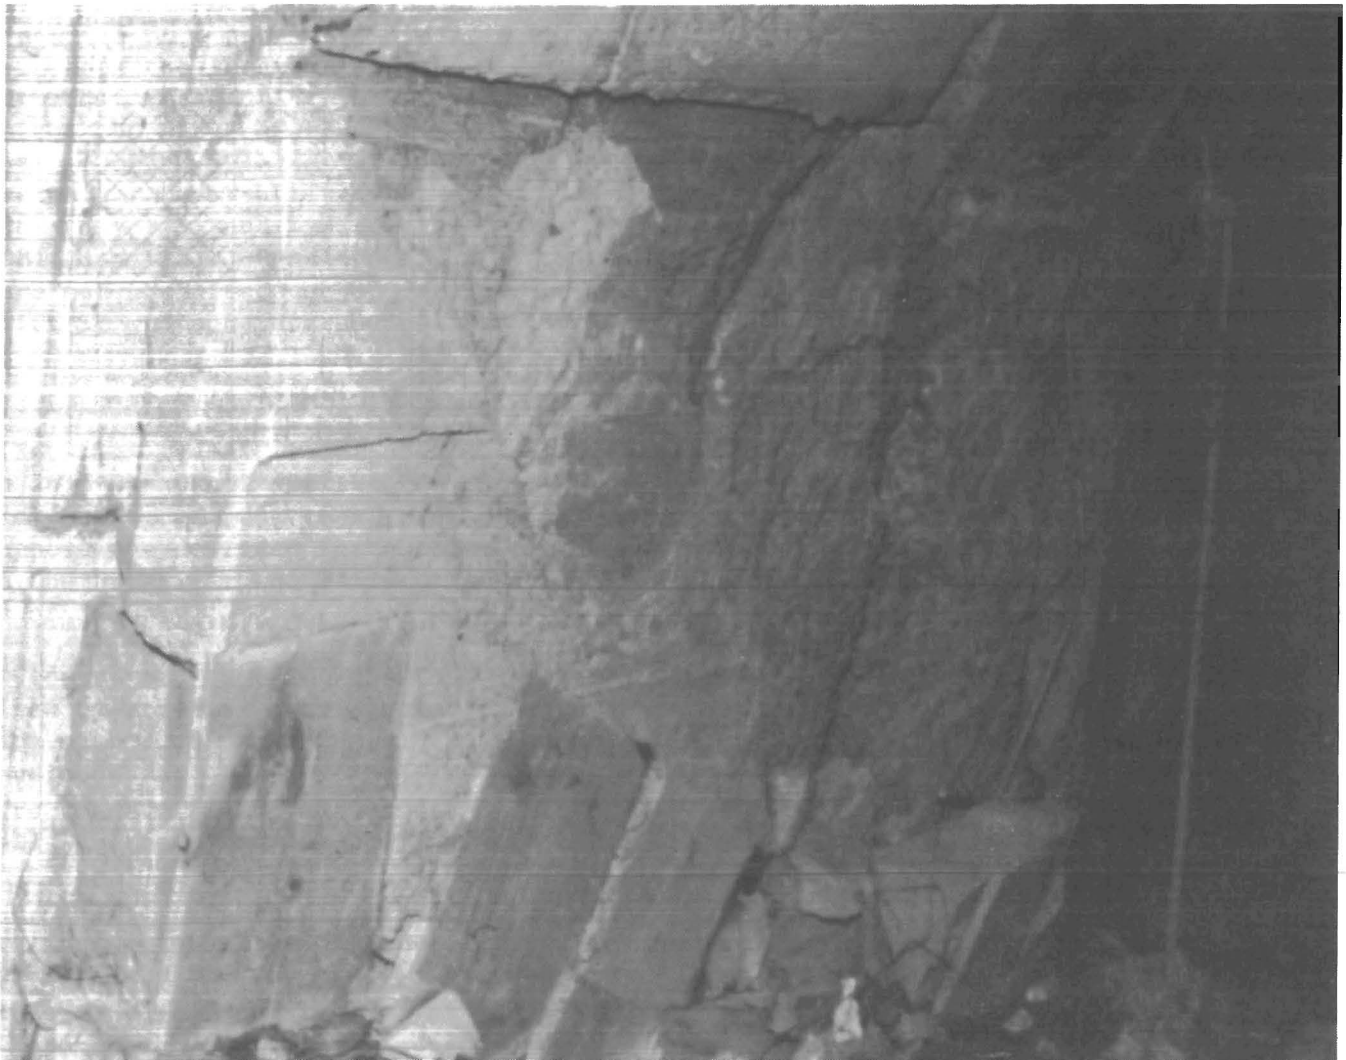
The monolithic concrete in 2615 GL panel drift adjacent to the test site failed (fig. 27) and was reinforced with 90-lb (40.8-kg) steel rail sets on 5-ft (1.52-m) centers. Likewise, rail sets were placed in the test section, after lagging and set failure, to stop further drift closure.

FIGURE 27. - Monolithic concrete failure in 2615 grizzly level.

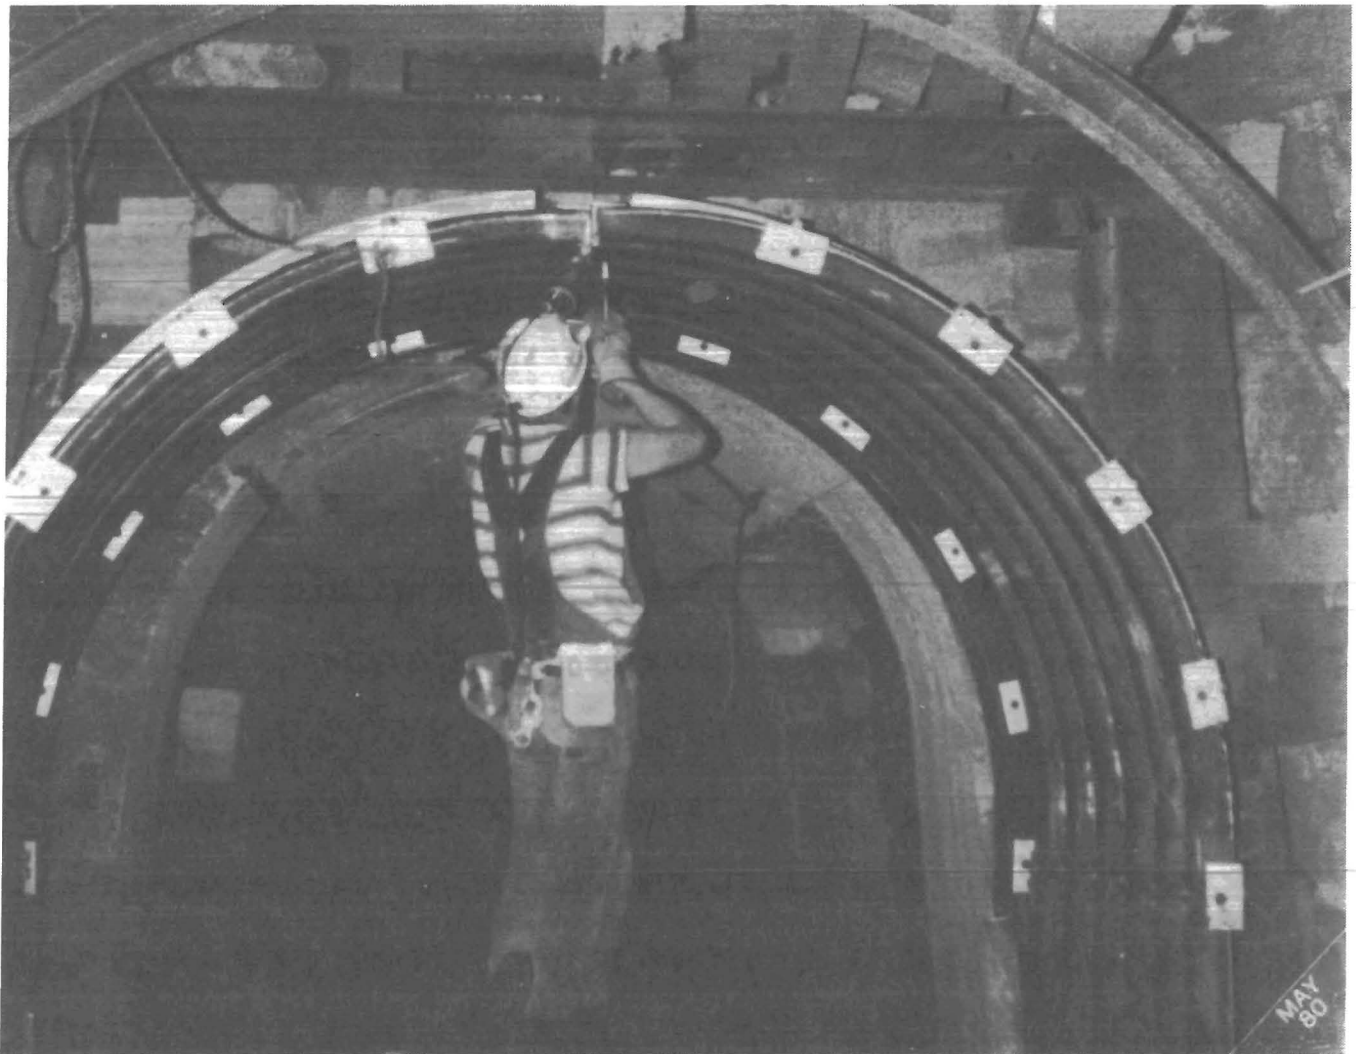
two aluminum plates at the top in 2615 posts with steel cap and rail set with GL; note the temporary support of wood wood lagging.

FIGURE 29. - Bolting two aluminum sheets at the top, 2615 grizzly level.
